Distribution: © BMW NA	Operating Manager	Sales Manager	Accessory Manager	Parts. Manager	Service Manager	Set-Up Workshop
Bulletin Date: 11/17/97 Bulletin #2798		Main Group: 11 Engine		For USA Only

Service Bulletin

Subject: K Models - Sealing Ring on Output Shaft

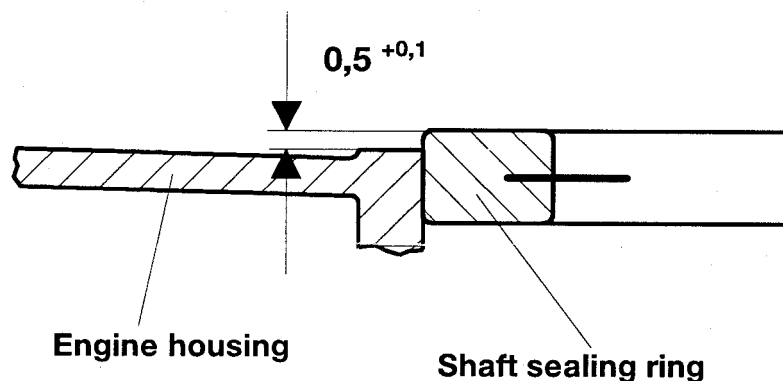
Problem: Leaking sealing ring at output shaft.

Cause: An unfavorable set of tolerances may cause the sealing lip of the shaft seal to rest partly on the chamfered area of the clutch support, with the effect that a perfect seal cannot be ensured.

Important: With tool BMW No. 88 88 6 111 630 as it is currently used by the retailer organization, the shaft sealing ring is driven $0.4^{+0.1}$ mm below the housing edge; **therefore it must no longer be used in the present form.**

Action: Effective from calendar week 14/97, the shaft sealing ring on production motorcycles will be installed with a projection of $0.5^{+0.1}$ mm towards the engine block surface.

Service remedy: If a complaint is received, the shaft sealing ring is to be driven into the engine housing so that this amount of projection is assured. Modification to special tool BMW No. 88 88 6 111 630

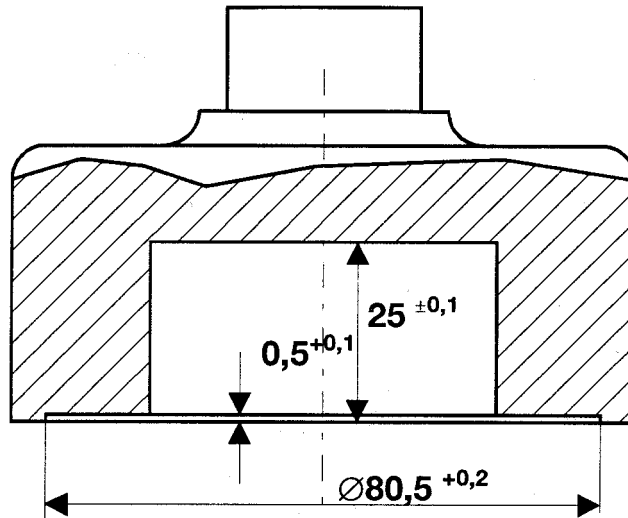
Sketch not true to scale, dimensions in mm.

The modified dimension ($0.5^{+0.1}$) on BMW No. 88 88 6 111 630 is illustrated in the above sketch. The BMW number remains unchanged.

Effective from calendar week 27/97, CARTOOL will supply tool BMW No. 88 88 6 111 630 only in its modified form (see sketch).

Machining the old tool or purchasing a new tool is required.
