# K Bike Water/Oil Pump Rebuild Using New-Style Seals Update #3

By Nick Stokes

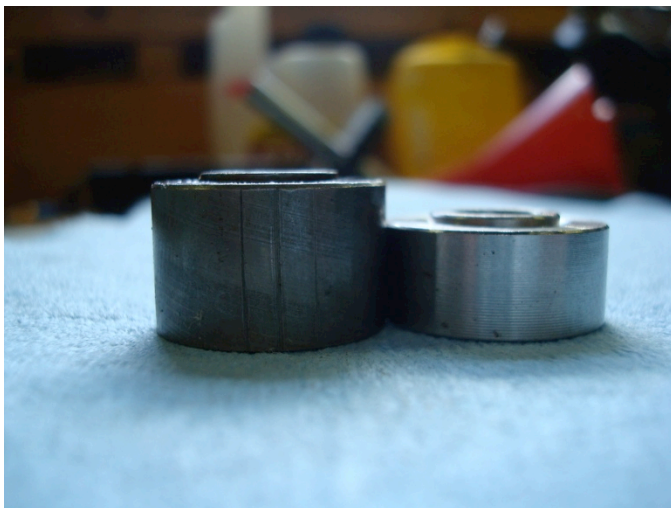
The original seal on my K75S used a spacer bushing 14mm long.

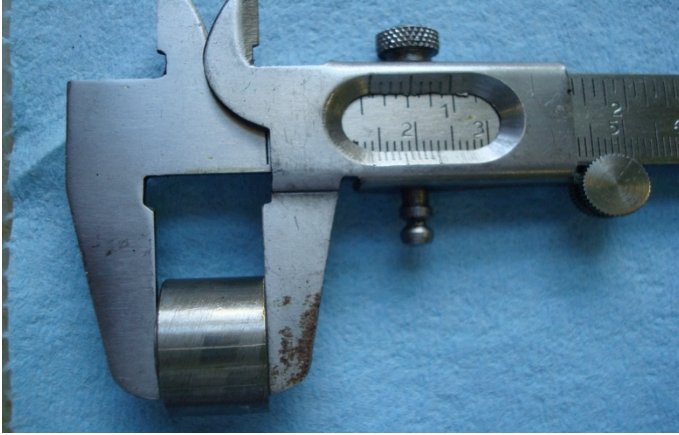
This spacer bushing is too long for use with the new slip-ring seal.

You must have spacer bushing #11511464902 which is 10mm long for use with slip-ring seal #11411741870.

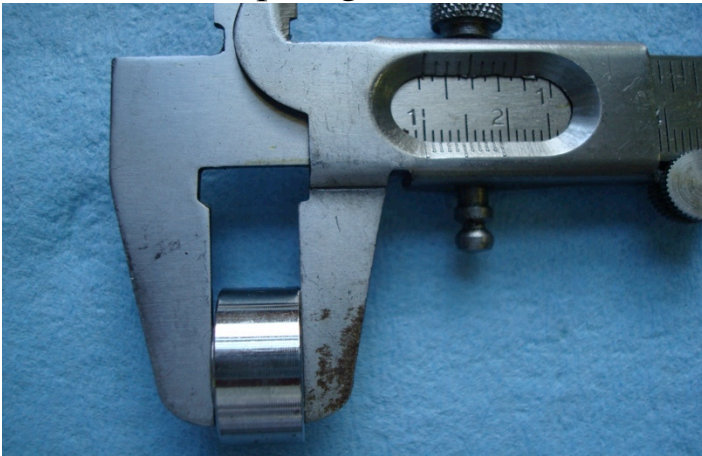
After using the new spacer bushing with the new slip-ring and spacer bushing, no leaks.
