Service-Information Motorcycle

21 006 89
(2355)

Oil Leak at the Clutch Push Rod Boot - R & K Models

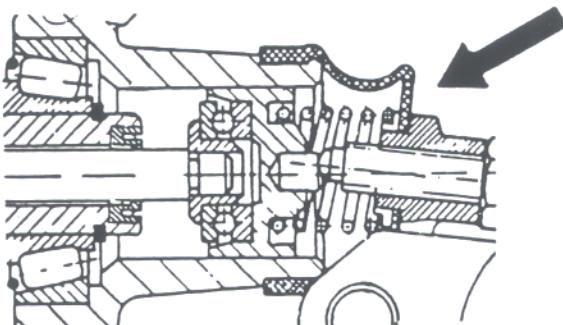
Problem: Gearbox oil leaking from the clutch push rod boot at the adjustment bolt.

Cause: Improper clutch adjustment. The coil spring cannot put enough pressure against the boot's sealing surface to contain the gear box oil when the clutch free-play is improperly adjusted. The greater the free-play, the further the sealing surface arcs back from the base of the spring.

Remedy: Adjust the clutch cable as described in the Rider's Manual or Workshop manual. It is extremely important to maintain the correct length of exposed cable at the gearbox clutch lever arm so that the coil spring under the push rod boot is at the proper tension.

Note: Most leaking boots can be corrected by cleaning the boot and seal surface, then re-installing and properly adjusting cable free-play.

Correct length of exposed cable: ("A" on dwg)

K Models 75 ± 1 mm
R Models $201 + 2$ mm
