Service-Information Motorcycle

21 006 89
(2355)

Oil Leak at the Clutch Push Rod Boot - R & K Models

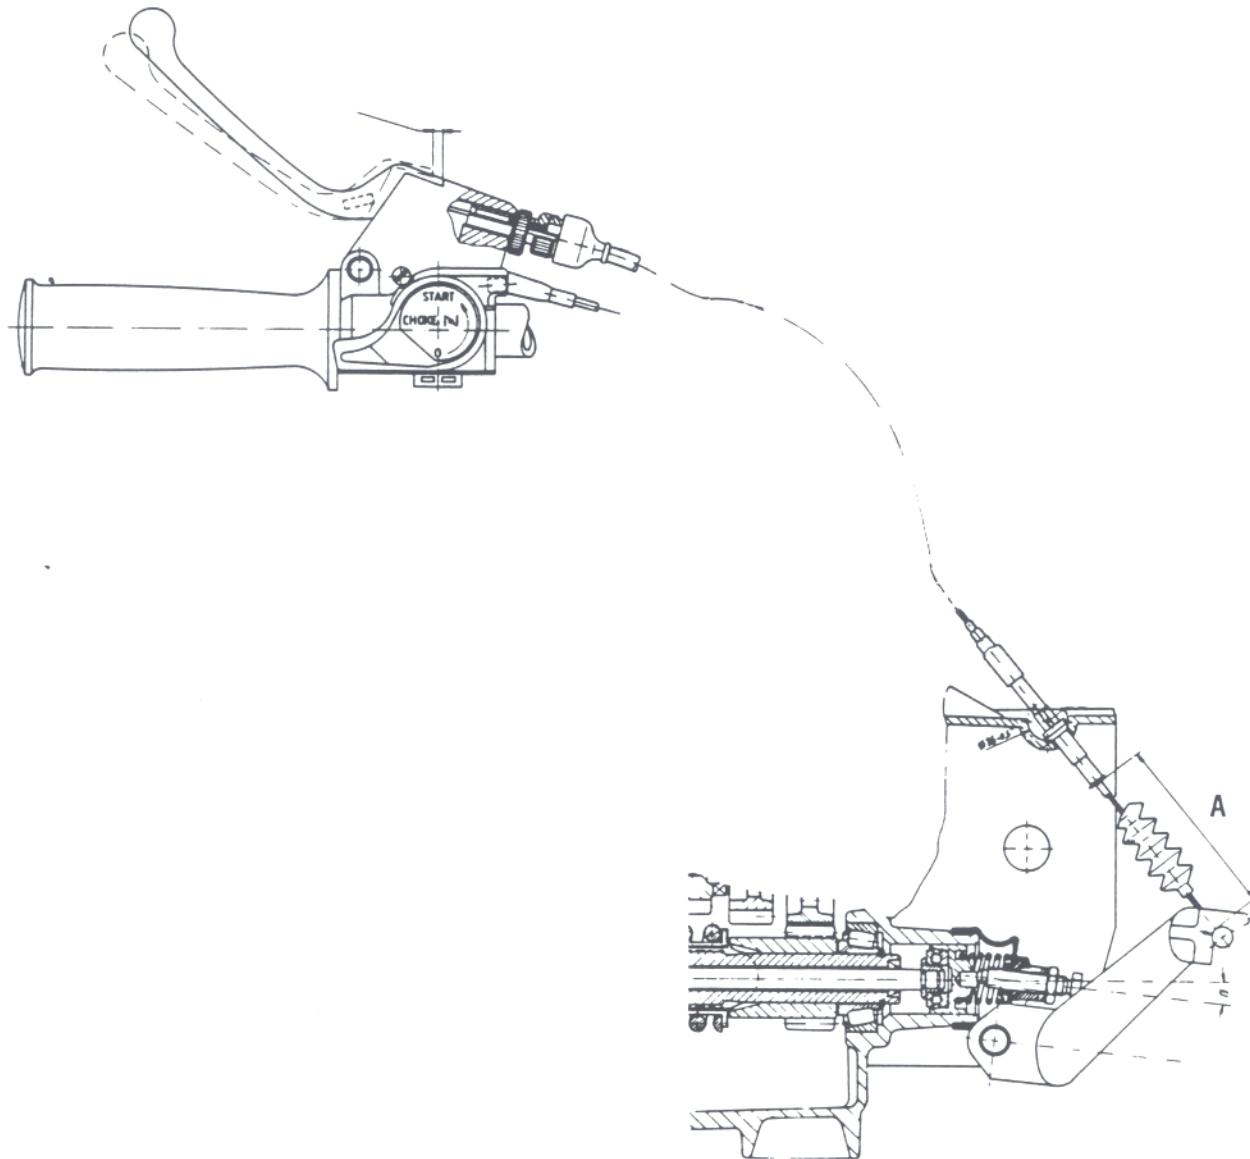
Problem: Gearbox oil leaking from the clutch push rod boot at the adjustment bolt.

Cause: Improper clutch adjustment. The coil spring cannot put enough pressure against the boot's sealing surface to contain the gear box oil when the clutch free-play is improperly adjusted. The greater the free-play, the further the sealing surface arcs back from the base of the spring.

Correct length of exposed cable: ("A" on dwg)

K Models 75 ± 1 mm
R Models $201 + 2$ mm

Remedy: Adjust the clutch cable as described in the Rider's Manual or Workshop manual. It is extremely important to maintain the correct length of exposed cable at the gearbox clutch lever arm so that the coil spring under the push rod boot is at the proper tension.

Note: Most leaking boots can be corrected by cleaning the boot and seal surface, then re-installing and properly adjusting cable free-play.
